## TECHNICAL BULLETIN

**Document:** T\_F421\_016  
**Date:** 07 June 2023  
**Subject:** Steering column check

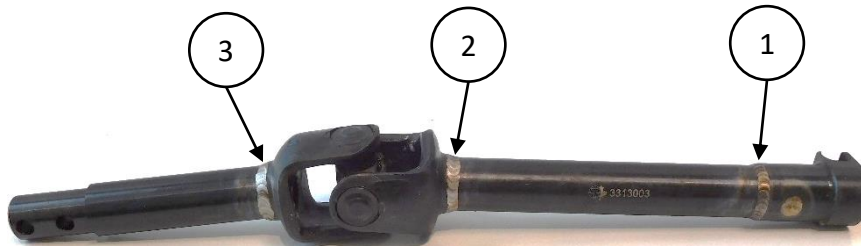
Figure 1, p/n 3313003

It is reminded to the teams to check the steering column parts after each major crash and to inspect them periodically with 5000 km intervals. The check should include a die penetrants inspection of the welded junctions on the parts listed below:

If the die penetrant inspection reveals any evidence of cracks it is necessary to immediately swap the damaged part.
